WindEnergy

ISSUE 42 - 2018 | £7.50

MINIMISING YAW BRAKE NOISE

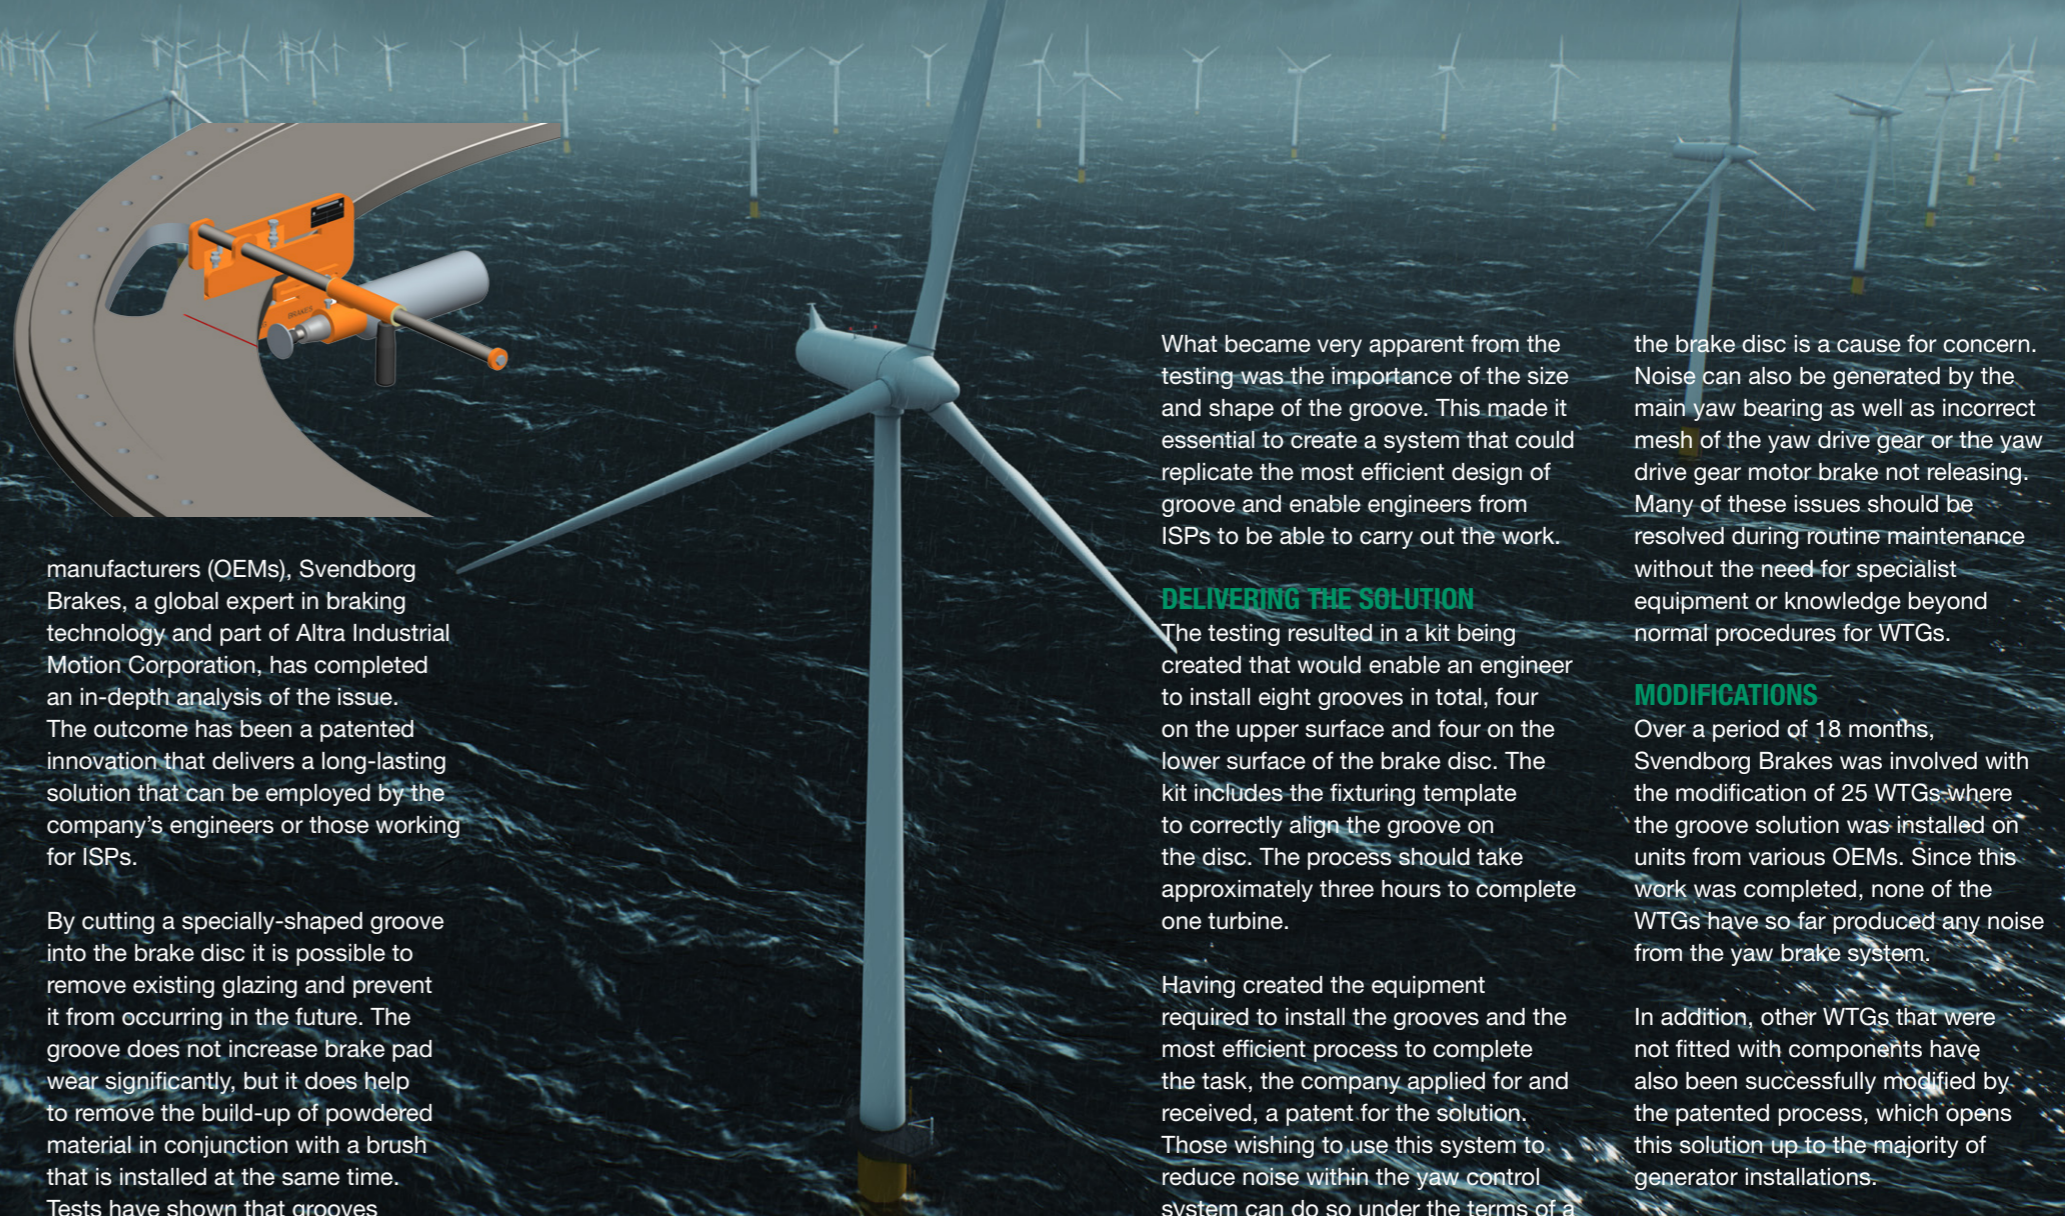
By cutting a specially-shaped groove into the brake disc it is possible to remove existing glazing and prevent it from occurring in the future. The groove does not increase brake pad wear significantly, but it does help to remove the build-up of powdered material in conjunction with a brush that is installed at the same time. Tests have shown that grooves cut into the brake disc removed the glazing on the brake pad and increased pad wear by only 3.5 percent, when operating at a pressure of 30 bar. These tests were conducted using brake pads from Svendborg Brakes that include a slot in the friction material that also helps to keep the braking surface clear of debris.

What became very apparent from the testing was the importance of the size and shape of the groove. This made it essential to create a system that could replicate the most efficient design of groove and enable engineers from ISPs to be able to carry out the work.

The testing resulted in a kit being created that would enable an engineer to install eight grooves in total, four on the upper surface and four on the lower surface of the brake disc. The kit includes the fixturing template to correctly align the groove on the disc. The process should take approximately three hours to complete one turbine.
